Manhole Inspection Summary

Manhole # S19EE2002MH

Location Address: **5748 FALLS RD**

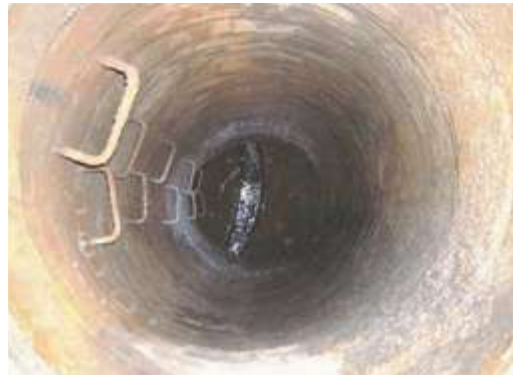
Top View

Corroded steps. Bench debris.

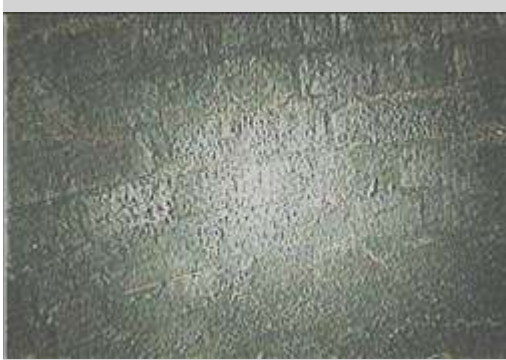
Defect

Barrel infiltration.

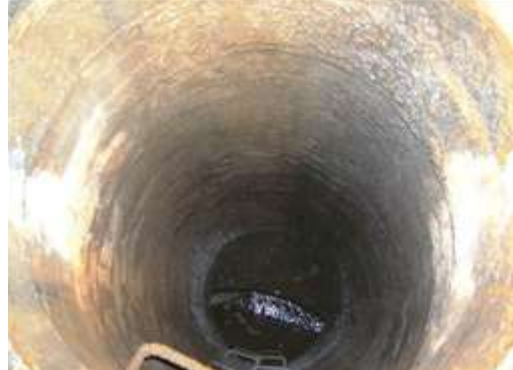
Defect

Frame leaks. Adjustment and Corbel infiltration - other side.

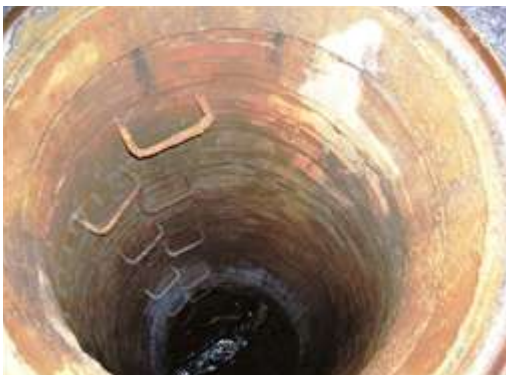
Defect

Frame leaks. Adjustment and Corbel infiltration.

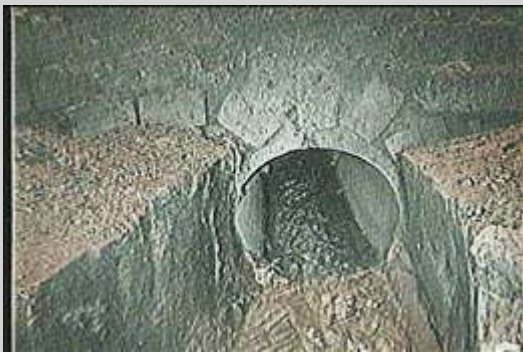
10 in. Circular Gravity Sewer Pipe Out @ 12 O'Clock

Comments **The O12 pipe picture shows Channel deterioration.**

Condition: ☐ Sound ☐ Cracked ☐ Root Intrusion ☒ **Deteriorated** ☐ Leaks ☐ Debris

Deposits: ☐ None ☒ **Mud** ☐ Sludge ☒ **Debris** ☐ Grease

Silt Depth: **0.5** (in.) Deposits Extent: **Light**

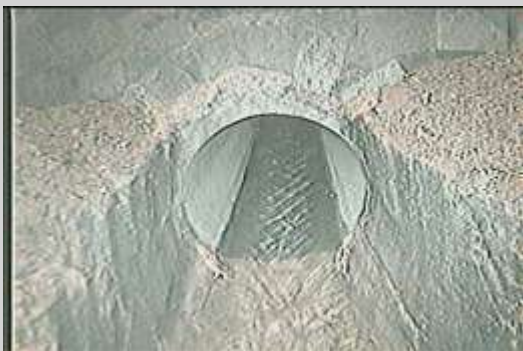
10 in. Circular Gravity Sewer Pipe In @ 7 O'Clock

Infiltration: **Evidence** Pipe Seal Cond: **Unknown**
